NOISE INVESTIGATION AND REPAIR OF THE EBR-II INTERMEDIATE HEAT EXCHANGER

H. W. Buschman, B. C. Cerutti,
and A. F. Clark

EBR-II Project

August 1971

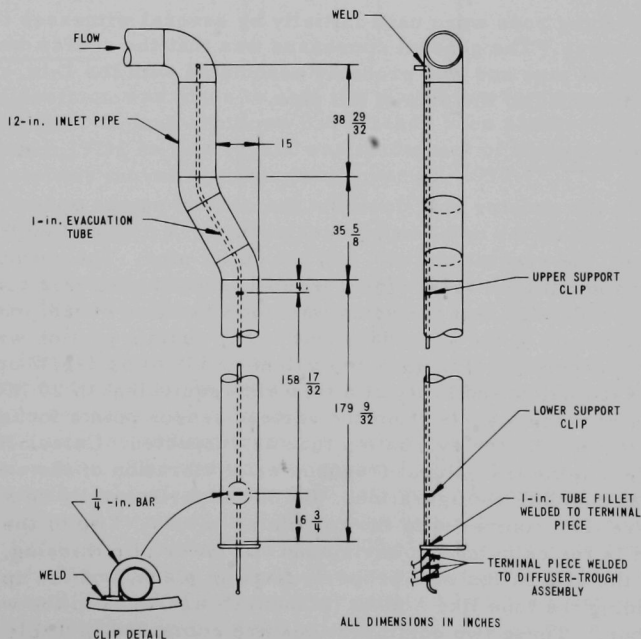
Fig. 4. IHX Inlet Pipe and Evacuation Tube. ANL Neg. No. 103-P5394.

A 1-in.-dia stainless steel tube was located inside the inlet pipe (as shown in Fig. 4) for the purpose of evacuating the secondary side of the IHX in the event that the IHX needed to be removed from the primary tank. This tube penetrated the inlet pipe at the inlet elbow above the shield plug and followed the wall of the inlet pipe to the bottom of the IHX, where it was socket-welded into a stainless steel terminal piece. This terminal piece penetrates and is welded to the diffuser-trough assembly, then terminates against the inside of the lower head of the IHX. The evacuation tube was anchored to the wall of the inlet pipe in two places by 1/4-in.-dia stainless steel rods (support clips) welded to the side of the inlet pipe and bent around the tube.

The decision was made to repair the IHX by removing the top clip and the evacuation tube rather than trying to reattach the tube to the inlet-pipe wall. The function of the evacuation tube could be met in the future by installing a pump-out tube as needed.

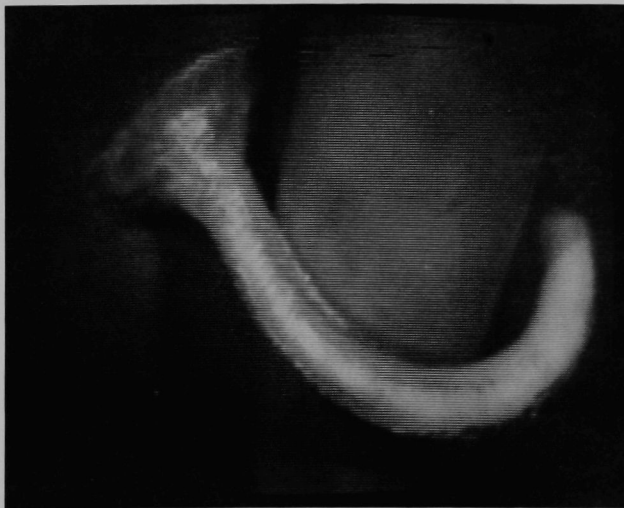
Fig. 13

A second inspection was made with the periscope, aided by the quartz lamp. It was found that the upper clip was indeed sprung away from the

1-in. evacuation tube and that the lower clip was broken off and missing. Nothing unusual was observed in the diffuser-trough assembly. TV pictures were taken through the periscope.

Television View of Upper
Support Clip. ANL Neg.
No. 103-05002.

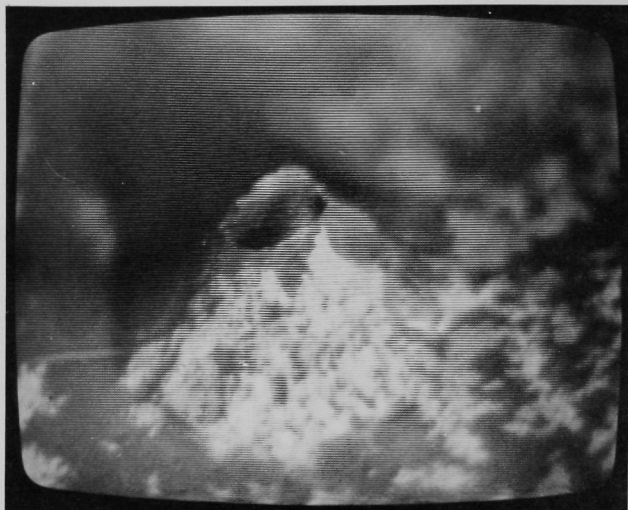
Fig. 14

Television View Showing
Weldment Where Lower
Support Clip Was Welded
to 12-in. Pipe Wall. ANL
Neg. No. 103-05005.

Figure 14 shows the remaining portion of the lower clip, essentially the weld portion. The white spots appear to be sodium deposits. A dark band (not shown) on the tube adjacent to the stub of the lower clip appeared to be the mark left by the lower clip before the clip was broken. Figure 15 is an overall view of the diffuser-trough assembly and support ribs. The lower end of the evacuation tube is also shown in this view. The white areas again appear to be sodium deposits. Figure 16 is a closeup of the terminal piece for the evacuation tube.

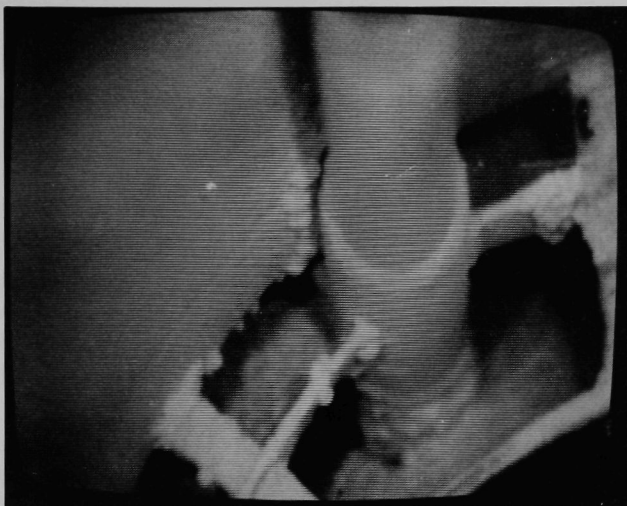
Fig. 16. Television View of Lower End of Evacuation Tube, Showing Fillet Weld to Terminal Piece That Penetrates the Diffuser Troughs. ANL Neg. No. 103-05001.

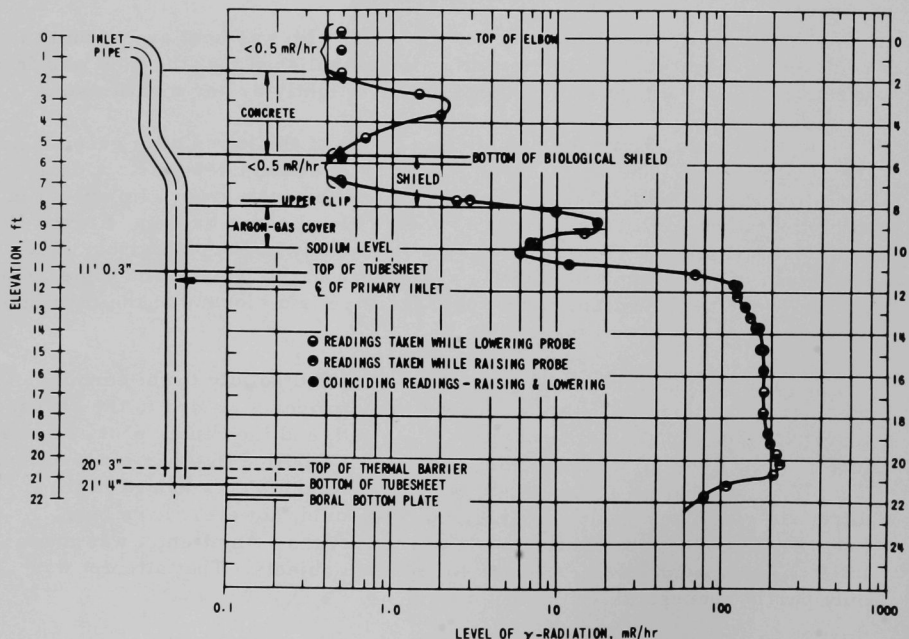
The gross gamma scan of the IHX inlet pipe was repeated, using a Jordan Radector with a range of 0-500 R/hr. The results indicated a maximum radiation level of about 230 mR/hr at the level of the primary-sodium exit just above the top of the thermal barrier. The gamma profile, along with significant IHX parts, is shown in Fig. 17. The profile has a one-to-one correlation with the structural elements of the IHX. The peak at the 9-ft level

Fig. 17. Results of Scan of EBR-II IHX with Jordan Radector. ANL Neg. No. 103-05811 Rev 1

corresponds to sodium scale, which may accumulate at the top of the sodium liquid like scum on a bathtub, and has been similarly found on other assemblies removed from the primary tank. The high levels between 12 and 21 ft correspond to the primary-flow portion of the IHX, with the peak appearing at the outlet below the borated shield. The reduction in radiation level at 22 ft corresponds to the reduction in intensity expected behind the shielding at the bottom of the IHX.

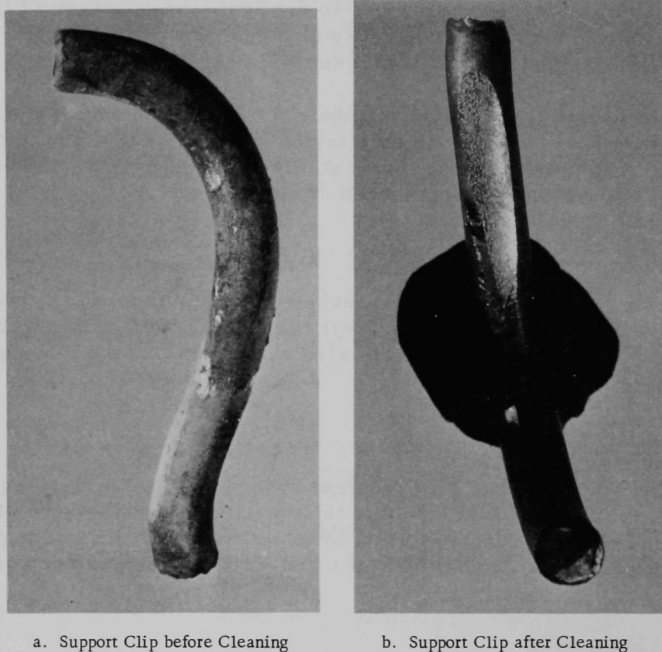
Figure 18 shows the upper clip after removal. The clip as shown in Fig. 18a is still covered with sodium oxide, while in Fig. 18b it has been cleaned. If one ignores the tool marks, the wear mark made by the 1-in. evacuation tube is apparent. A matching groove was seen on the evacuation tube when it was withdrawn. The weld stump appeared similar to that remaining at the lower-clip location.

Fig. 18. Photographs of the Removed Upper Support Clip.
ANL Neg. Nos. 103-05209 and 103-05213.

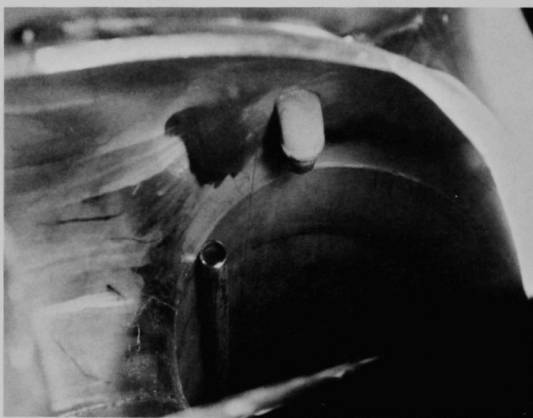
Figure 21 is a view into the IHX inlet pipe showing the cutoff end of the evacuation tube. This picture is taken through the Plexiglas view plate on the access port.

Fig. 21. Cutoff Evacuation Tube inside the IHX
Inlet Pipe. ANL Neg. No. 103-05253.

The evacuation tube was cut off just inside the inlet-pipe elbow. The cut was made with a tungsten-inert-gas (TIG) welding torch. The tools used for this operation are shown in Fig. 19. The end of the tube was then cut again with a tube cutter to leave a smooth end. The end of the tube after being cut off is shown in Fig. 20. Several long thin slivers of molten material were left in the evacuation tube from the TIG cutting operation. These slivers were removed on January 18 with wire brushes. One small sliver was lost in the inlet pipe and not recovered.

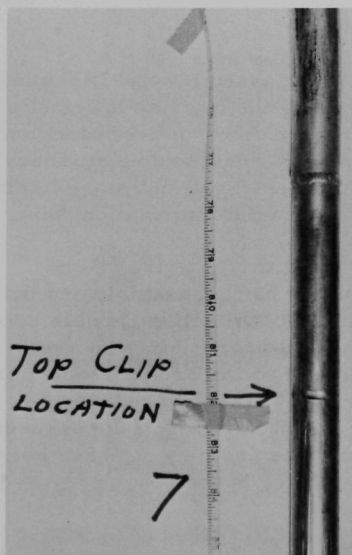
The tube showed wear spots at numerous places along its length. The most prominent rub marks, caused by the upper clip and the weld on the 12-in. pipe just above the clip, are shown in Figs. 24c and 24d.

The depth of the wear mark made by the clip was about 0.025 in., and that made by the inlet-pipe weld was 0.029 in. The evacuation tube was activated only at the lower end of its length; the maximum gamma measurement was 1-2 mR/hr at contact.

c. Evacuation Tube with Rub Mark
from Upper Clip

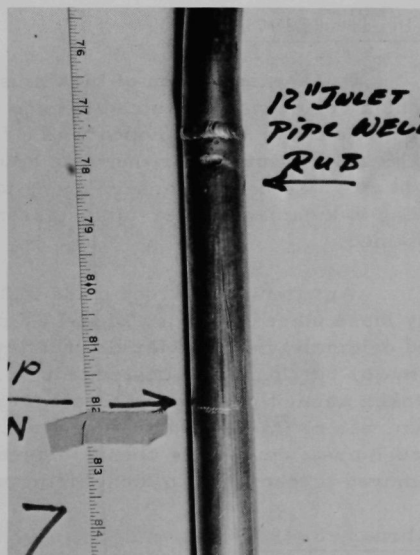
d. Evacuation Tube with Rub Mark
from Weld on 12-in. Pipe

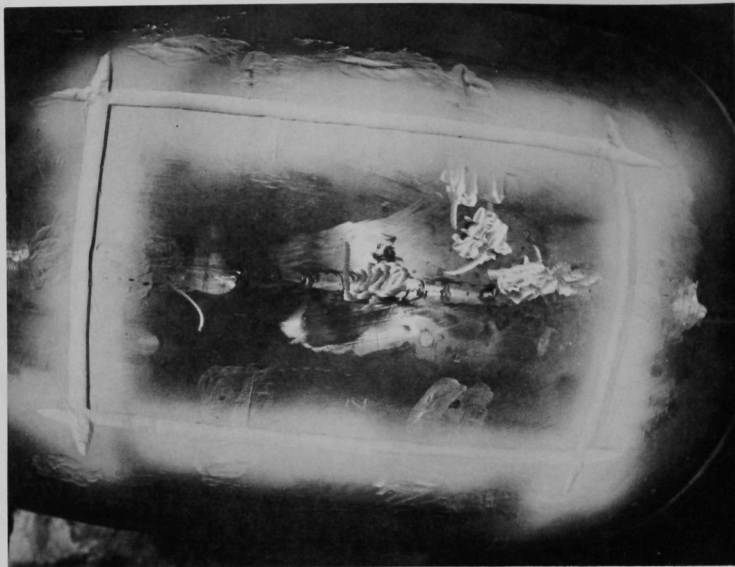
Fig. 34. Inlet-elbow Closure Weld after Second Pass, with Liquid Penetrant Applied. ANL Neg. No. 103-05628.

The IHX inlet elbow was reclosed without difficulty using the procedure developed on the test elbow (see Appendix B). In preparation for welding, the removed section was trial-fitted into the elbow, and a measurement was made of the amount of metal that had to be removed to establish the proper weld-joint gap for insertion of the consumable insert (Y-ring). The edge of the removed section was ground back, and the consumable insert was tack-welded to it. The elbow portion of the weld joint needed no additional preparation except deburring and cleaning. Deburring was accomplished as soon as the patch was removed by first inserting a catch pan

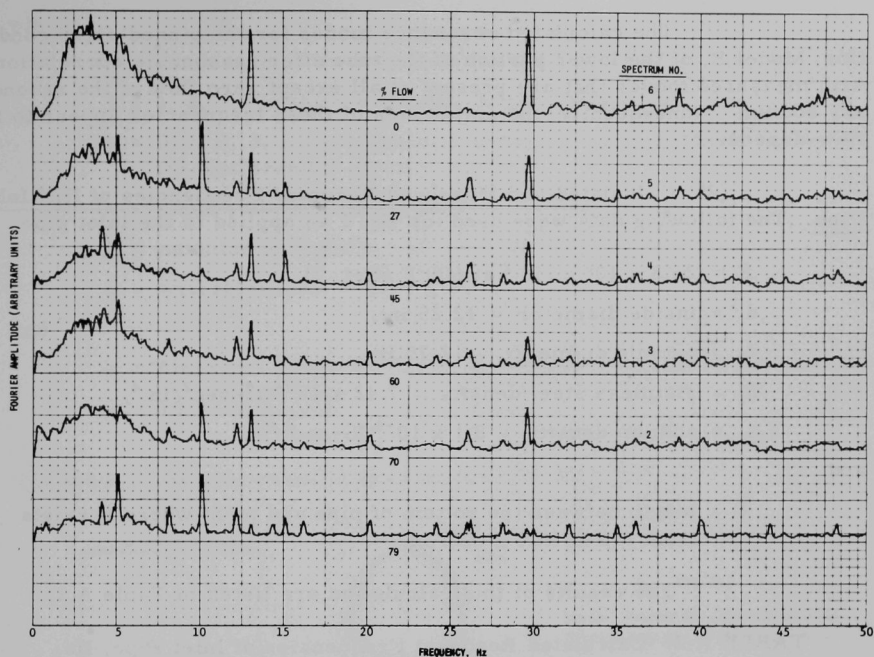
Fig. A.6. Noise Spectrum of IHX with Varying Secondary Flow Taken November 17, 1970 (accelerometer on evacuation tube). ANL Neg. No. 103-P5245.

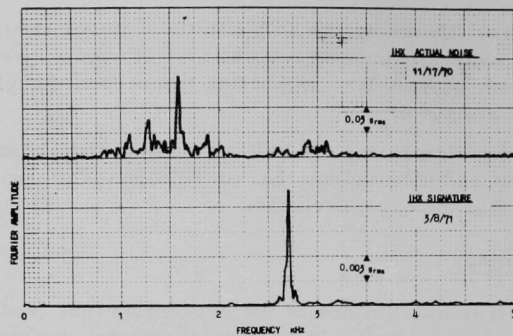
Fig. A.8. Noise Signature for IHX Outlet Pipe at 62.5-MWt Reactor
Power before and after Repair. ANL Neg. No. 103-P5251.
